Document ID# 1861645
2004 Cadillac CTS

Subject: **Diagnostic Trouble Code (DTC) P0757 Set, Malfunction Indicator Lamp (MIL) Illuminated, Poor Performance of Transmission/Slipping (Clean Transmission Valve Body and Case Oil Passages of Debris) #01-07-30-038D - (09/12/2006)**

Models: **2007 and Prior GM Passenger Cars and Light Duty Trucks**
2003-2007 HUMMER H2
2006-2007 HUMMER H3
2005-2007 Saab 9-7X
with 4L60-E/4L65-E/4L70-E Automatic Transmission (RPOs M30/M32/M70)

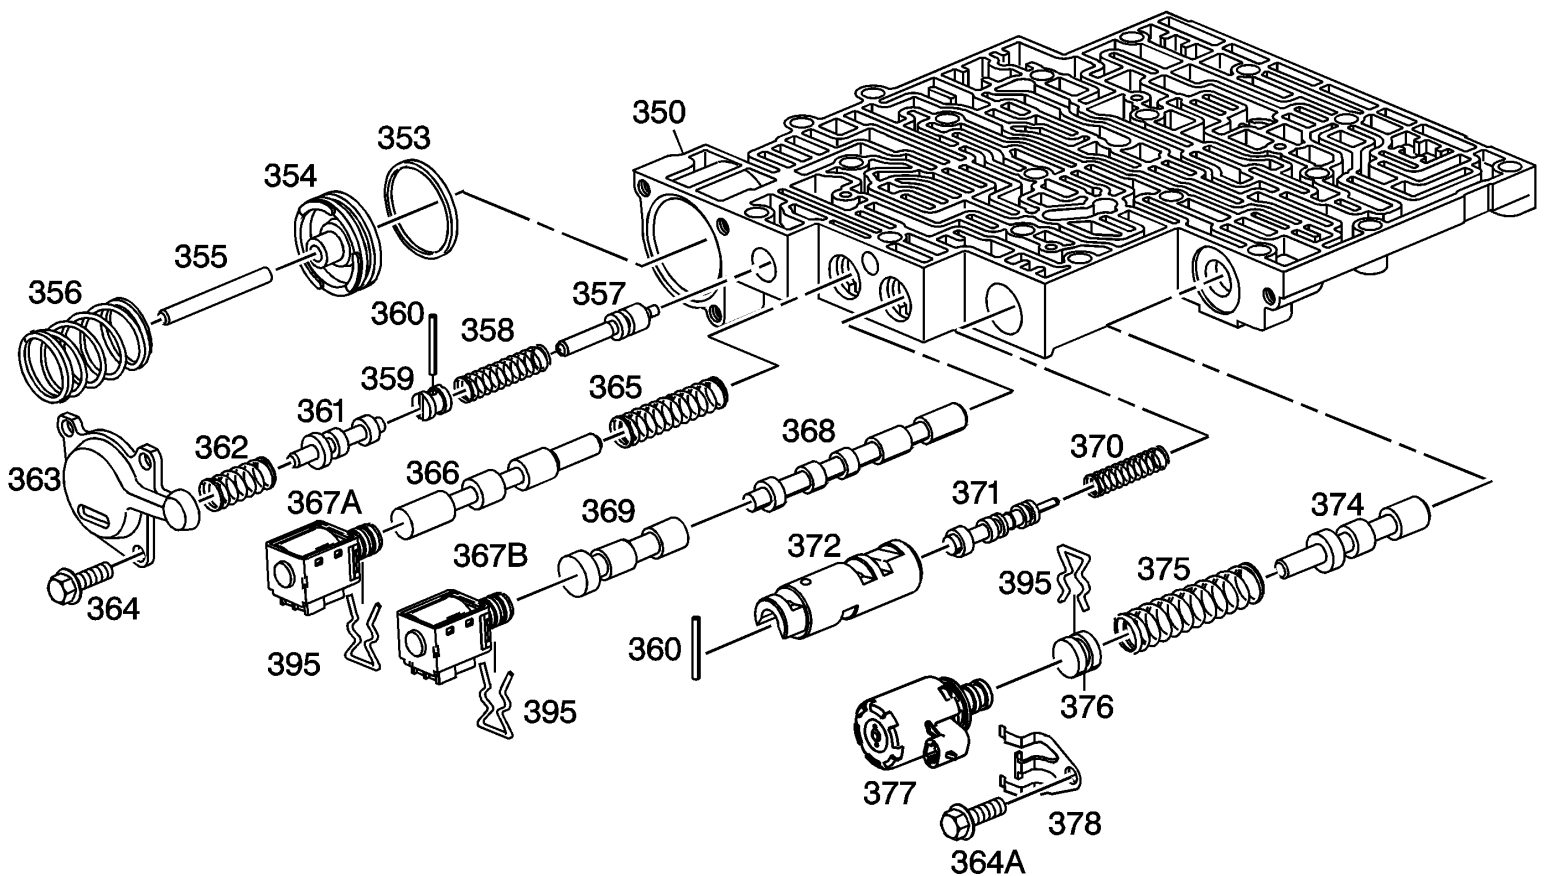
This condition may be caused by any of the following:

- Chips or debris plugging the bleed orifice of the 2-3 shift solenoid (367). This will cause the transmission to stay in 2nd gear when 3rd gear is commanded and return to 1st gear when 4th gear is commanded.

- A 2-3 shift valve (368) or 2-3 shuttle valve (369) that is stuck, restricted and/or hung-up in its bore.
- This condition may also be an indication of a damaged 2-4 band or 3-4 clutches. This clutch damage may generate debris causing the 2-3 shift valve line-up to stick in the valve body bore and set DTC P0757.

- Inspect and clean the 2-3 shift valve (368), the 2-3 shuttle valve (369) and the valve bore of debris/metal chips.
- Inspect and clean the 2-3 shift solenoid (367B) opening of debris/metal chips. While inspecting the 2-3 shift solenoid (367B), look for a screen over the solenoid opening. If the solenoid DOES NOT have a screen, replace the solenoid. All current GMSPO stock shift solenoids have a screen over the solenoid opening.
