Service Steering System Message On, Diagnostic Trouble Code (DTC) C0450 or C1241 Set (Replace Variable Effort Steering (VES) Solenoid) #03-02-36-001A - (Mar 16, 2004)

2003-2004 Cadillac CTS

2004 Cadillac CTS-V

with Variable Effort Steering (RPO FE3) or Suspension System Special Ride and Handling (RPO FE4)

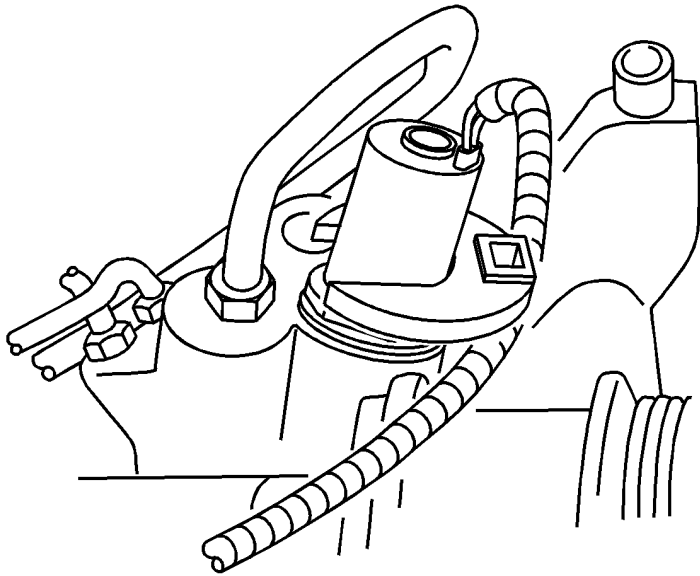
6. Disconnect the VES solenoid harness retainers and electrical connector.
7. Measure the resistance of the VES actuator.
 - If the resistance IS between 5.7-7.2 ohms, for 2003 model years, continue with DTC C1241 Diagnosis. Refer to SI Document ID #813282. For 2004 model years, DTC C0450, refer to SI Document ID #1219432.
 - If the resistance IS NOT between 5.7-7.2 ohms, continue with the next step.

8. Using the open end crows foot provided with the solenoid, remove the VES solenoid from the steering gear.

9. Install the new VES solenoid, P/N 89060234, into the steering gear with the open end crows foot provided with the solenoid. **Tighten**

Tighten the VES solenoid to 21 N·m (4.71 lb ft).
