Document ID# 1874387
2005 Cadillac CTS

Subject: 5.7L LS1, LS6, 6.0L LS2, 5.3L LS4, L33, LH6, LM4, 7.0L LS7 - Engine Oil Leak at Rear Cover Assembly Area (Engine Block Porosity RTV Repair Procedure) #05-06-01-034C - (11/29/2006)

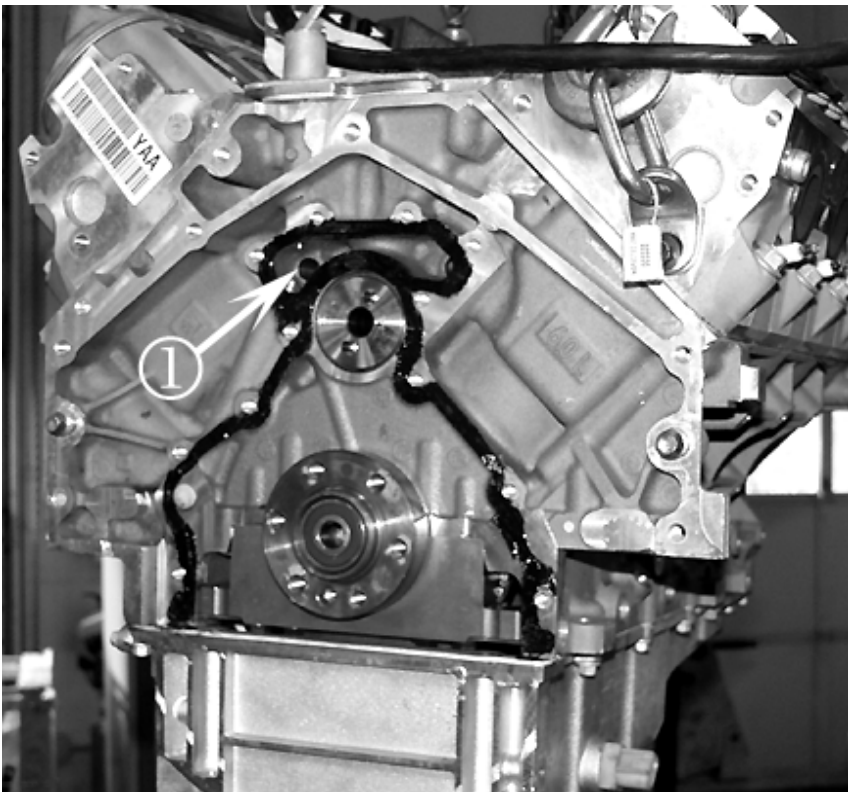
Upon initial diagnosis, it may be determined that the leak is coming from the rear cover gasket. This condition may be caused by engine block porosity on the sealing surface.

Follow the steps for Oil Leak Diagnosis in SI to determine the source of the leak. If the leak has been diagnosed as coming from the engine rear cover assembly, refer to Engine Rear Cover Replacement in SI and remove the engine rear cover assembly. Inspect for engine block porosity where the engine rear cover mates to the engine block. If porosity is found anywhere on the sealing surface, use the following procedure to apply RTV to repair the engine block porosity. Refer to the illustration below.

Important: Clean any residual oil from the block and cover before applying the sealant in the next step.

1. Wipe a small amount of RTV, P/N 12378521 (in Canada, use P/N 88901148), onto the surface using a plastic scraper to fill the porosity.
2. Remove any excess RTV material, especially from inside the high pressure oil passage. Refer to #1 in the above illustration.
3. Allow the RTV to cure for 10 minutes.

4. Reinstall the engine rear cover using a new gasket and a new crankshaft rear main seal. Refer to Engine Rear Cover Replacement in SI.
