Document ID# 1664357

2004 Cadillac CTS

Reduced Engine Power, Service Engine Soon (SES) Light with One or More DTCs P0121, P0221, P2119, P2122, P2138, P2176 (Replace Throttle Body Assembly and Harness Connector to Throttle Body) #05-06-04-032A - (May 25, 2005)

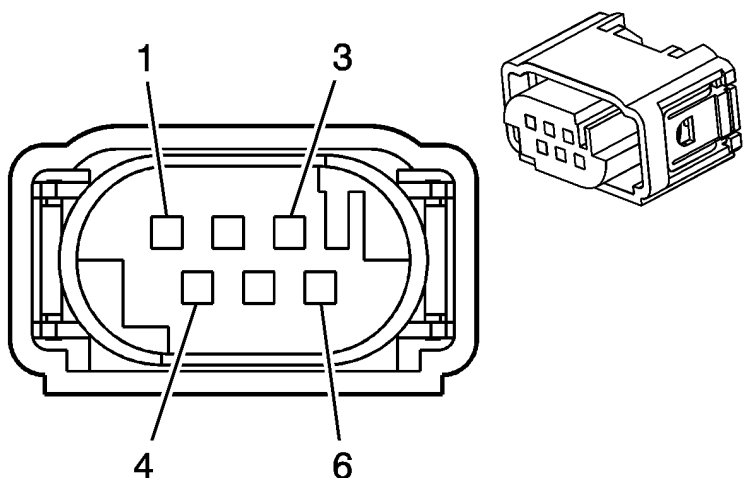
FIGURE Original Throttle Body Assembly Harness Connector(c)

The condition may be caused by a poor connection at the throttle body electrical connector.
