**Document ID# 1663262
2005 Cadillac CTS**

**3.6L LY7 with Cam Actuator DTC - keywords
camshaft crankshaft MIL reluctor SES P0008
P0009 P0016 P0017 P0018 P0019 #PIP3423 - (May
24, 2005)**

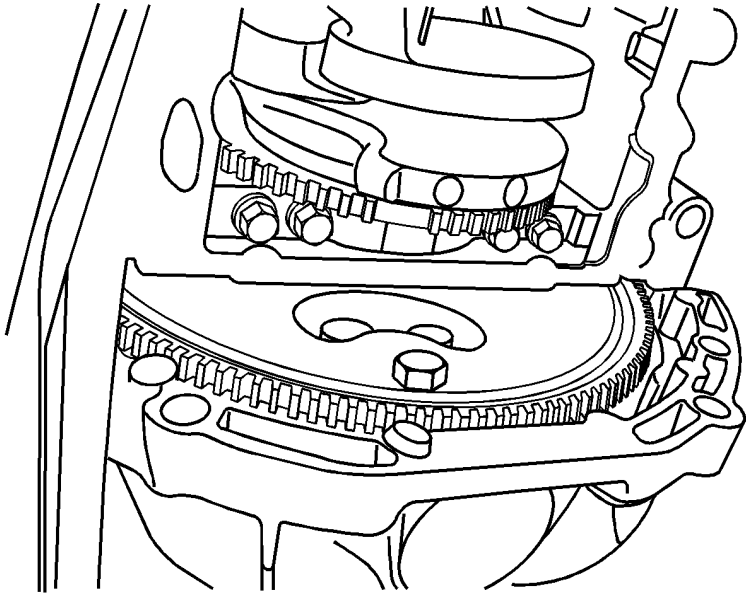
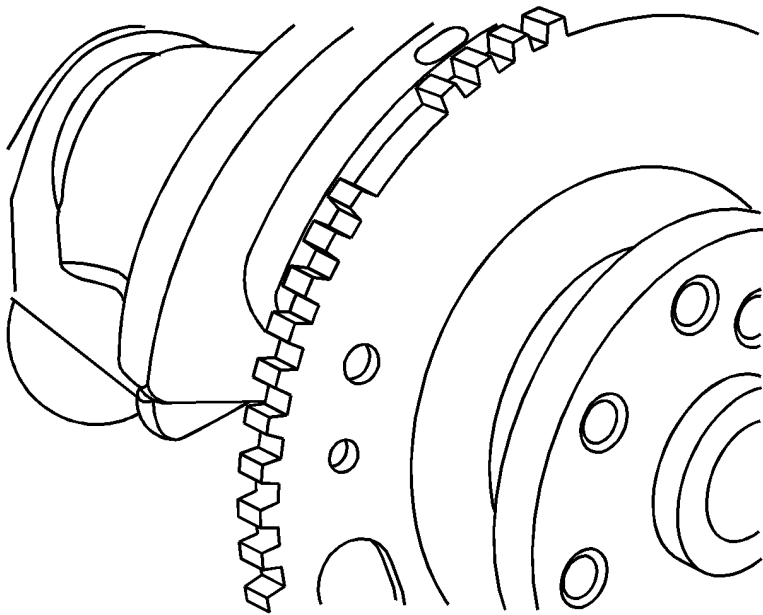
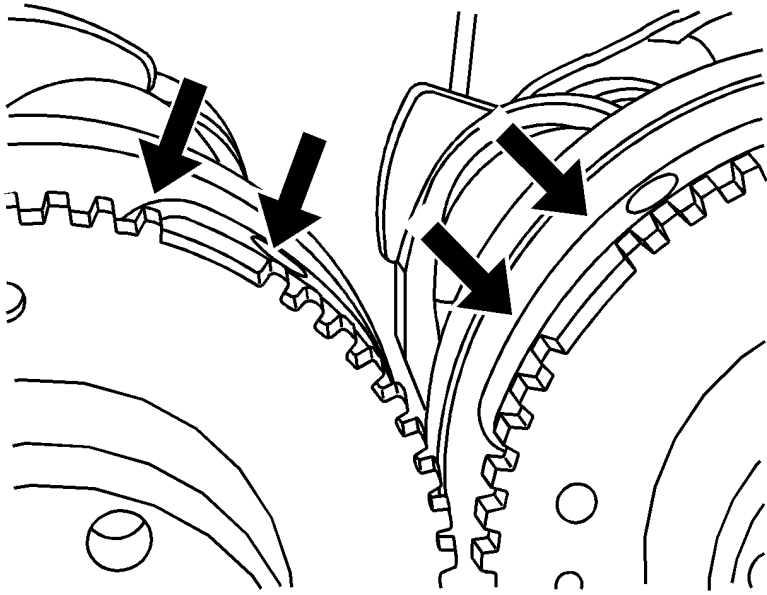
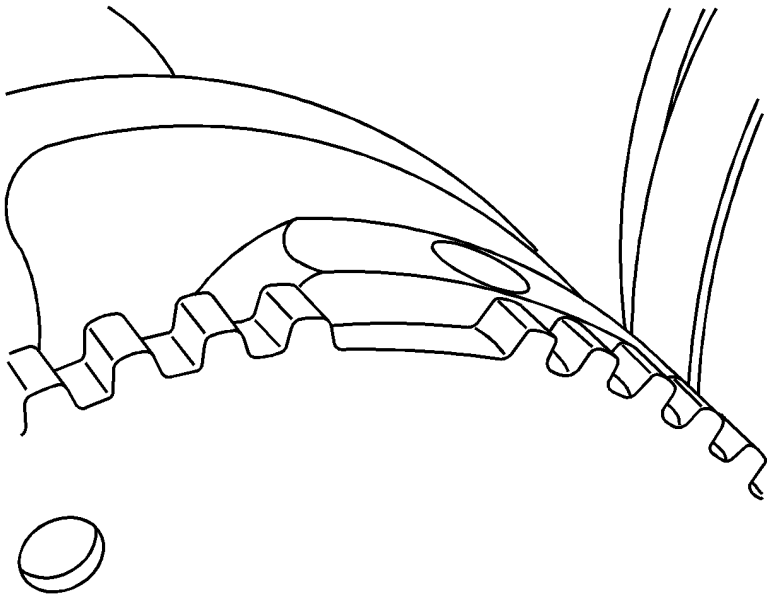
The reluctor for the crankshaft sensor pressed on the crankshaft may have moved. Refer to attached photographs for exact location.
