Document ID# 1527280 2004 Cadillac CTS

4T65-E Automatic Transmission Fluid Leak From Reverse Servo Cover (Replace Reverse Servo Cover and Seal) #04-07-30-028 - (Jun 15, 2004)

2004 and Prior Cars and Light Duty Trucks

with Automatic Transmission 4T65-E (RPOs MN3, MN7, M15, M76)

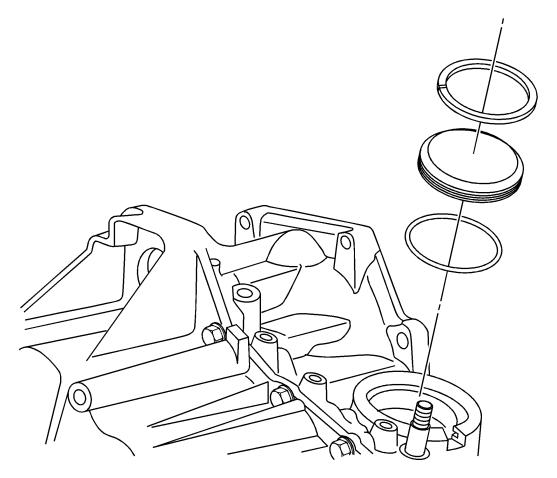
A possible cause of a transmission fluid leak usually only during cold ambient temperatures below - 6.7° C (20° F) may be the reverse servo cover/seal. The reverse servo cover seal may shrink in cold ambient temperatures causing a transmission fluid leak.

1. Diagnose the source of the fluid leak. Refer to Fluid Leak Diagnosis, SI Document ID #634313.

- 2. If the source of the transmission fluid leak is the reverse servo cover, replace the reverse servo cover and seal with P/N 24207376. Refer to Reverse Servo Replacement in the appropriate service Manual.
- 3. Clean the area around and below the cover.
- 4. Inspect the transmission fluid level. Refer to Transmission Fluid Checking Procedure in the appropriate service Manual.
